West Lake Landfill Radiological Survey May 16, 2013

Hazardous Waste Program Federal Facilities Section May 2013

Section 1: Site History

Section 2: Gamma Radiation Survey

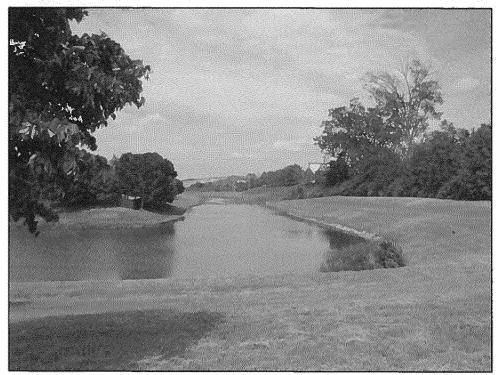
Photo 1: Location #4 looking Northeast toward landfill.

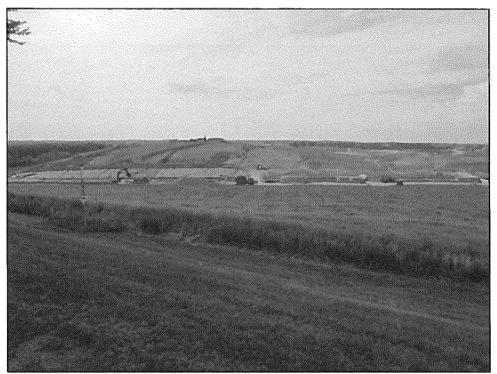
Observations and Discussion: Wind direction was sporadic during the initial data collection but became predominantly to the northerly direction as the day progressed. Wind direction is recorded near the site by the department's meteorological station. See Section 5, Photo #3.

Photo 3: Location #7, Turner property, looking North toward landfill. Note the meteorological station in left foreground.

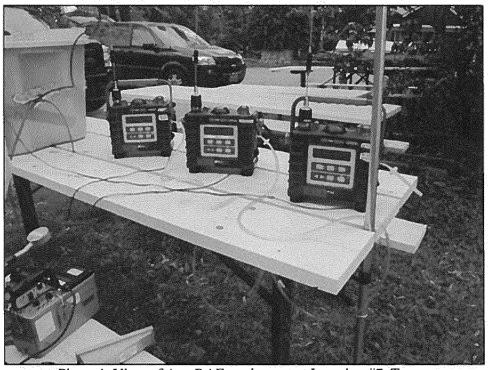
Introduction: Staff also collected dust swipe samples at two locations at the perimeter of the site. These locations were selected since they typically have high odor and may contain dust originating from the site. The first was adjacent to the leachate pumping station southwest of the landfill and the second was a private residence, Turner property, south of the site. Included below are field instrument surveys and benchtop readings of dust swipes. Benchtop readings were collected with a Ludlum model 2929 scalar ratemeter with 43-10-1 detector that was designed for these samples. It is noted that EER has gamma monitors, namely AreaRAE equipment, stationed at these locations. Please see Section 5, photo #4.

Photo 4: View of AreaRAE equipment at Location #7, Turner property. Swipe samples #3 and #4 collected at this location.
